## Improved pump reliability.

## ‘Reduced maintenance through improved reliability’

Industry:	Oil & Gas
Product:	CAPI-23 Single Seal with API 23 Seal Support System using double Python cooler
Application:	Cooler water
MTBF Increase:	500%
Savings:	£343,000 ROI: <10 months
Reference N.O:	CH01447

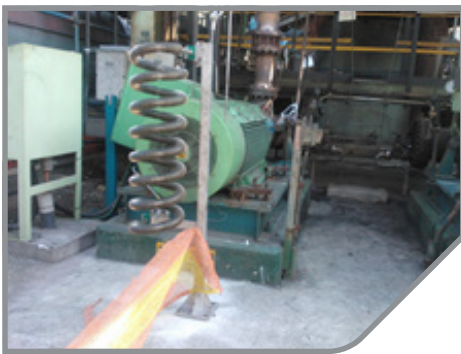
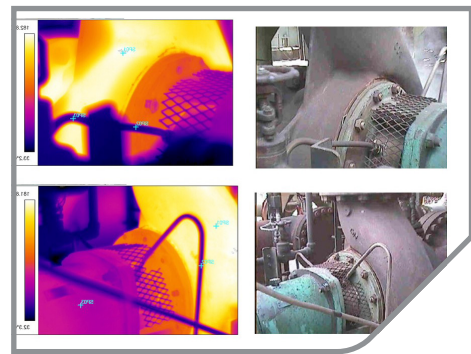
A major oil refinery in South Africa had an unreliable mechanical seal on a cooler water pump. Despite competitors trying a number of different seal support system configurations, the seal was failing approximately every 6 to 9 months. This was as a result of dry running, causing vaporisation, damaged elastomers, seal face wear and pump bearing failure as a result of heat transfer.

AESSEAL® installed a CAPI A type 23 mechanical seal along with an API Plan 23 seal support system, utilising a double Python cooler. The new solution eliminated the need for frequent maintenance and has been operating for over 54 months. Subsequently the customer upgraded eight similar pumps on the plant.
