Improved Reliability for difficult application

Industry:	Power
Product:	HPVS™
Application:	Water Circulating Pump
MTBF Increase:	800%
Savings:	£180,000
Reference N.O:	CS0021

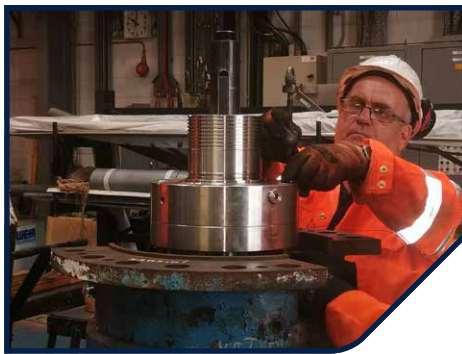
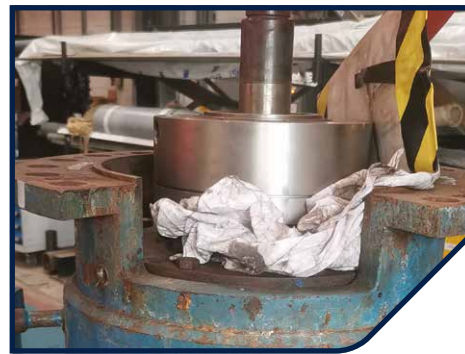
A power plant in the UK were having frequent failures of the mechanical seal on a water circulating pump.

The mechanical seal was failing on average every 8 weeks. The cost to replace the mechanical seal was very high as the pump needed to be removed from its operating location to be stripped down. After having poor service from the supplier of the original seal the company approached AESSEAL® for a solution.

AESSEAL® recommended replacing the seals with the HPVS™ seal. The HPVS™ seal is specifically designed for the high speed, high pressure duties found in this application. The new seal was installed in July 2020 and has worked without issue for over 18 months.
