Preventing toxic leakage and improving reliability

Industry:	Pulp & Paper
Product:	CDSA™ and Water Management System
Application:	Chlorine Dioxide Generator recirculation pump
MTBF Increase:	1 year and counting
Reference N.O:	CS0022

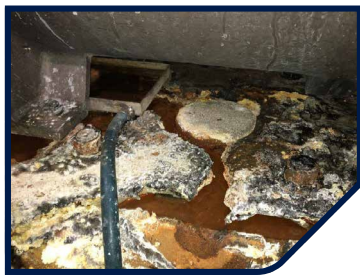
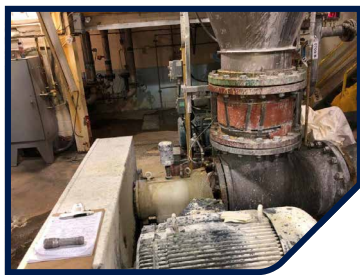
Before

Leakage from the gland packing, coupled with the leakage as a result of multiple earlier seal failures was leading to excessive corrosion of the pump and its mounting base. In addition, the highly toxic nature of the process fluid was a serious safety hazard and lead to the triggering of multiple gas alarms and local area evacuations.
