## MagTecta eliminates gearbox oil leakage

Industry:	Pulp & Paper
Product:	MagTecta™
Application:	Paper machine
Savings:	US\$50,000
Reference N.O:	CS0090

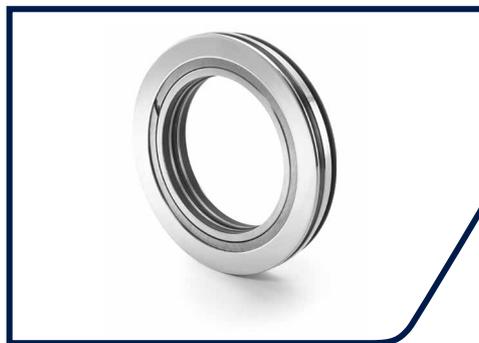
The gear box used a dual lip seal arrangement that over time was causing major damage to the gear box shaft, leaking oil which caused both a slip hazard and the potential to shut down the paper machine. The customer turned to AESSEAL® for assistance.

AESSEAL® recommended replacing the dual lip seal arrangement with the MagTecta™ bearing isolator. The MagTecta™ could be installed such that it avoided the damaged area of the shaft and therefore the original gear box shaft did not need to be replaced. The new solution was installed in July 2016 and has been running ever since with no oil leakage. By installing the new solution the customer made a saving of \$50,000.
