## LabTecta® saving time and money at US plant

## 'Oil leakage eradicated for more than 6 years'

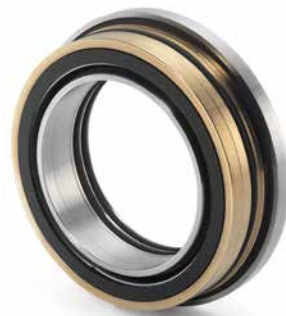
A water treatment plant in South Carolina was reporting problems with an oil seal, which had worn a deep fret mark in the output shaft of its Philadelphia Mixer Gearbox, which then leaked oil down through the worn-out mark.

This meant that the company had to continually refill the gearbox, and clean up the oil leakage from the surrounding area. There was also the added possibility of bearing failure.

AESSEAL's solution was to recommend the installation of its innovative LabTecta®FS bearing protector. This was installed in October 2016, and has been working efficiently ever since over 6 years later, with its non-contacting design preventing further damage to the equipment. It sealed beyond the fret mark, and allowed the customer to reuse the existing LabTecta®FS input shaft rather than having to order a replacement shaft from the original manufacturer. This has resulted in savings to date of more than \$1300. The floor is dry and clean, and there is no longer the necessity to continually replenish the oil in the gearbox.
