LabTecta® solves bearing problem

Industry: Corn Milling
Product: LabTecta®66
Application: Dodge pillow block
Reference N.O: TD3095463

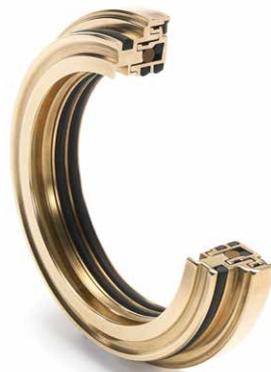
A US corn milling company was having a persistent problem with the failure of its dodge pillow block bearing.

The bearing was exposed to the elements, and inadequate protection meant that fine dust and moisture were contaminating the bearing grease.

The company asked AESSEAL® to provide a form of protection for the bearing, incorporating a split seal design so that it could be installed without the need for a crane to lift the shaft, which would have caused prolonged downtime, and additional costs.

The solution was the installation in May 2020 of two LabTecta® bearing protection seals, with a further two placed in reserve. The company also purchased two repair kits. Since the installation, the company has reported no further problems.
