## LabTecta® solves bearing problem

## ‘Split seal design cuts downtime and costs’

Industry: Bio-ethanol  
Product: LabTecta®66  
Application: Dodge pillow block  
Reference N.O: TD3095463

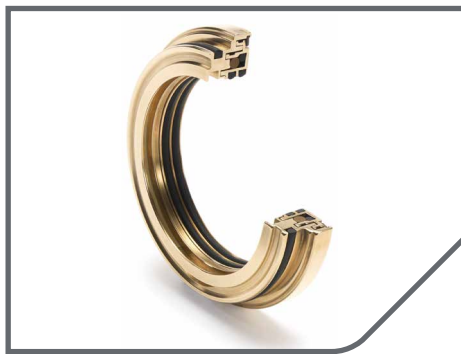
A US corn milling company was having a persistent problem with the failure of its dodge pillow block bearing.

The bearing was exposed to the elements, and inadequate protection meant that fine dust and moisture were contaminating the bearing grease.

The company asked AESSEAL® to provide a form of protection for the bearing, incorporating a split seal design so that it could be installed without the need for a crane to lift the shaft, which would have caused prolonged downtime, and additional costs.

The solution was the installation in May 2020 of two LabTecta® bearing protection seals, with a further two placed in reserve. The company also purchased two repair kits. Since the installation, the company has reported no further problems.
