Ingress Protection Test Report

LabTecta Bearing Isolator

AESSEAL plc

CML-IPTR18483-A

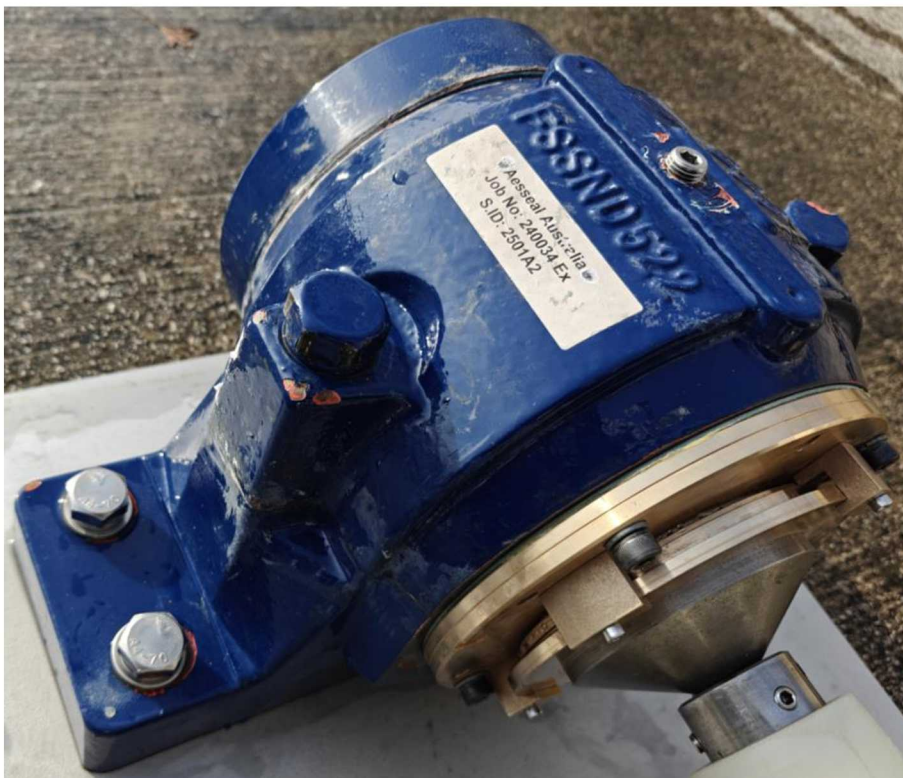
Figure 2 – Image of LabTecta Bearing Isolator

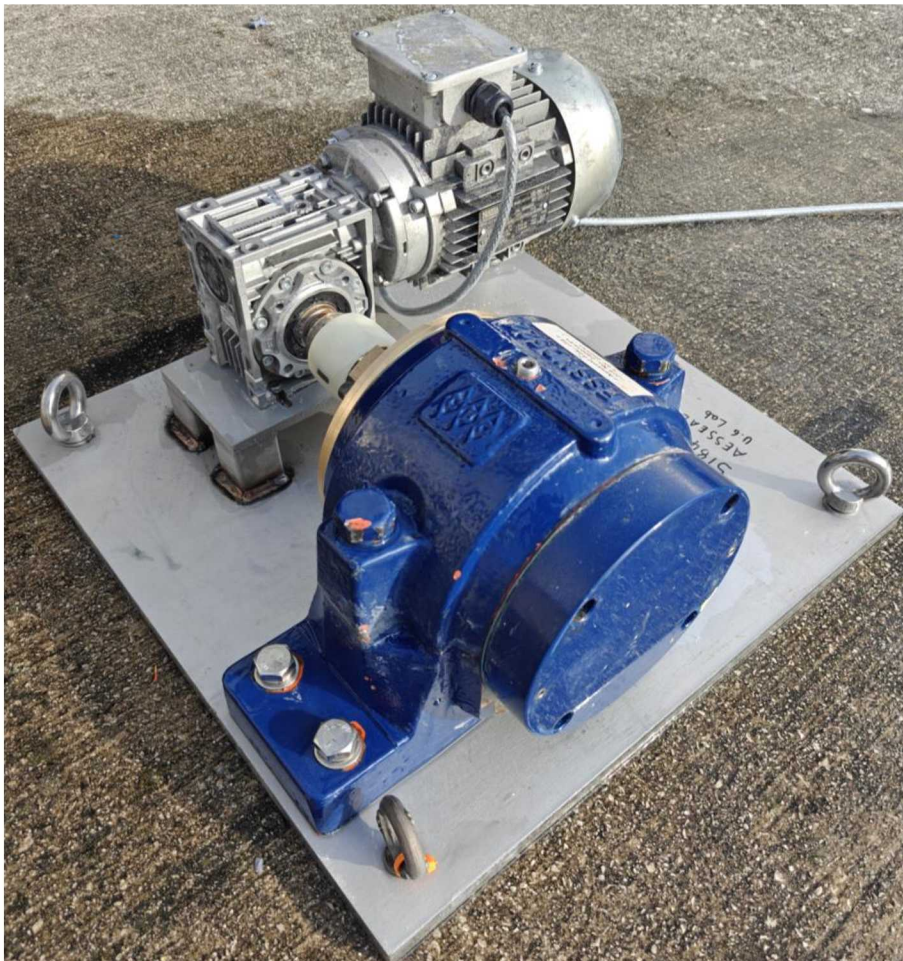
Figure 4 – Image of LabTecta Bearing Isolator and test bed shaft rotation apparatus setup

The sample was placed inside a chamber that was fitted with a powder circulation pump and contains approximately 2kg of powder per cubic metre with a maximum particle size of 75 μ m. The shaft of the sample was energised to a rotational speed of 150 RPM and remained in the energised state until the completion of the test. The sample was connected to a vacuum pump to draw air into the sample. The test duration was 8 hours.

The sample was mounted horizontally and the shaft of the sample was energised to a rotational speed of 150 RPM and remained in the energised state until the completion of the test. Water from a standard IPX6 water spray nozzle was directed at the sample from all practical directions. The sample was subjected to a flow rate of 100 L/min \pm 5 % from a distance between 2.5 to 3 metres for 3 minutes.

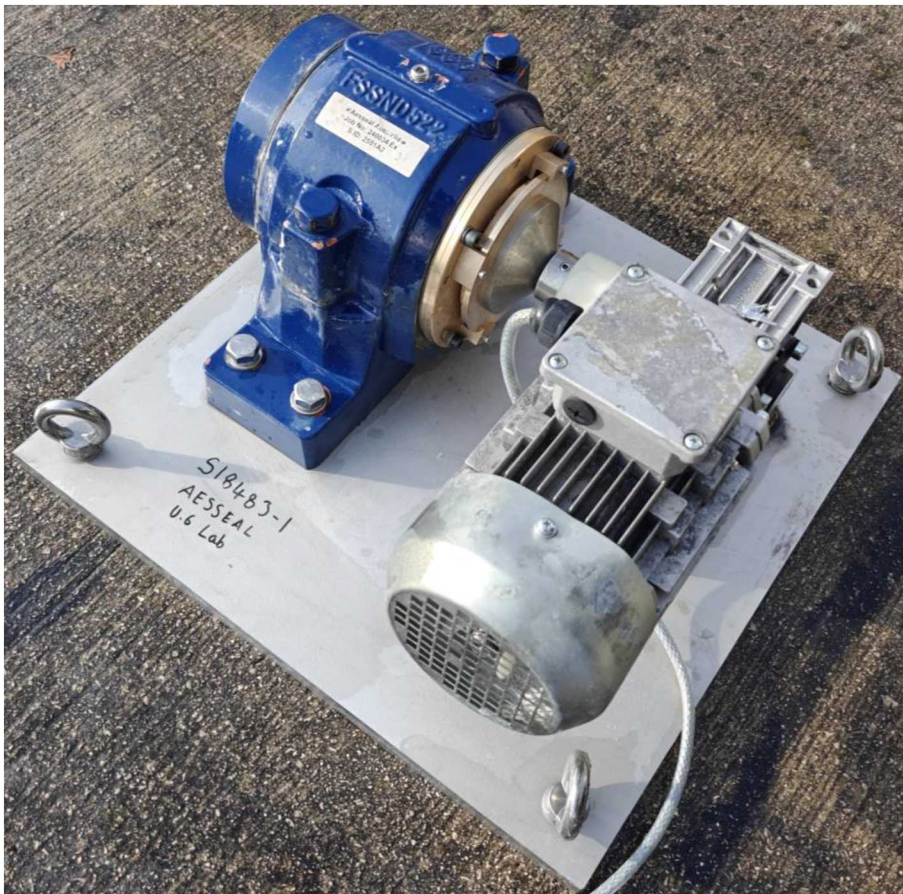
Figure 6 – Image of LabTecta Bearing Isolator and test bed with shaft rotation apparatus setup

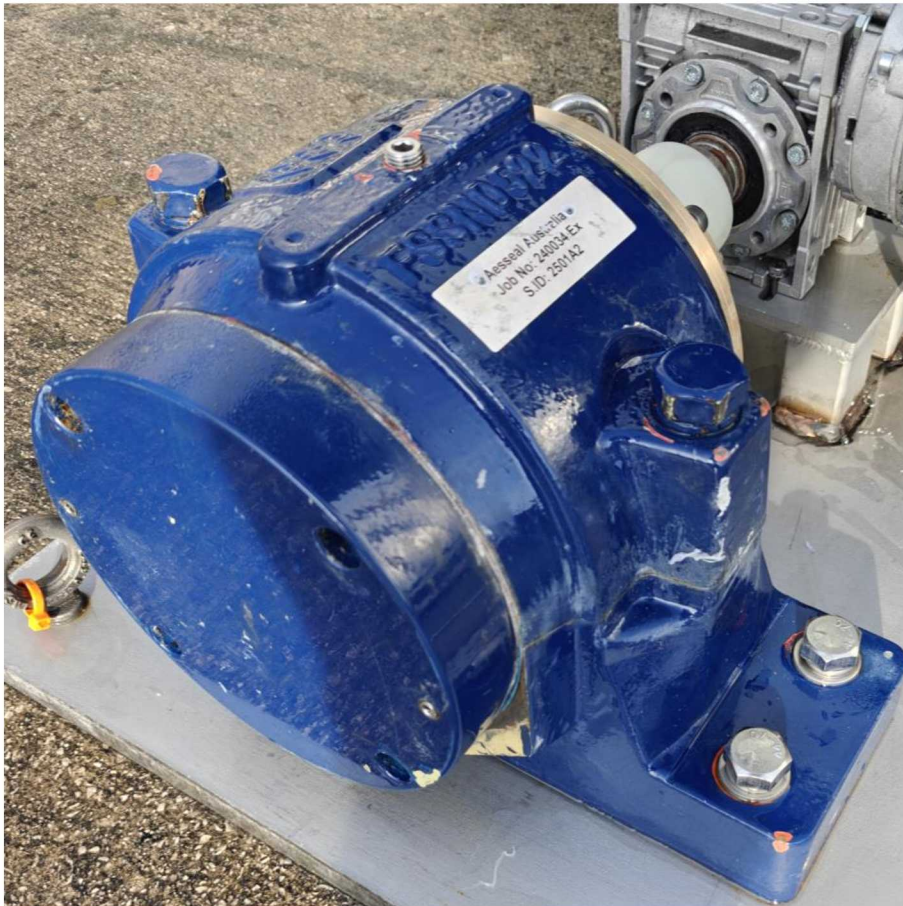
Figure 7 – Image of LabTecta Bearing Isolator and test bed with shaft rotation apparatus setup
