Trialling different solutions to improve MTBF

Industry:	Marine Indu
Product:	SMSSTM
Application:	(HPSW) hea
MTBF Increase:	500%
Reference N.O:	CS0197

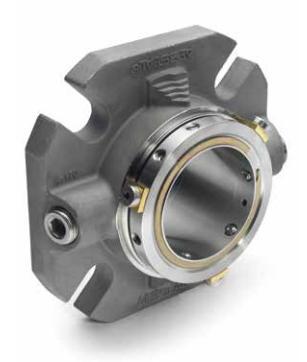
Designed for high movement and displacement

SMSS[™] cartridge seals which are designed for high movement and displacement applications were subsequently installed on the vessels where the MTBF has increased to from 6 months to 36 months.
