## **AESSEAL® upgrade solution leads to an 8 year failure free period**

Industry:	Metal Processing
Product:	CDSA and PUMPPAC™
Application:	Slurry Transfer Pump
MTBF Increase:	2300% (and counting)
Reference N.O:	CH00584

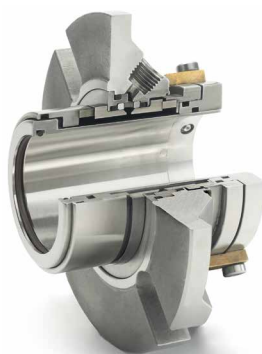
AESSEAL® installed a cartridge double seal (CDSA) and PUMPPAC™ forced lubrication support system. The PUMPPAC™ system was chosen because after investigating previous seal failures inconsistent pressure of the plants water line was leading to premature seal failure.

Since the upgrade, the AESSEAL® solution has been running trouble free for eight years, giving the customer a massive 2,300% mean time between failure increase. The CDSA and PUMPPAC™ solution has also eliminated expensive maintenance costs and the continuous production outages that occurred previously.
