ENVIRONMENTAL TECHNOLOGY

Chemical plant saved over €500,000 in the first year

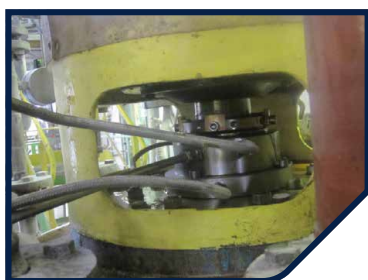
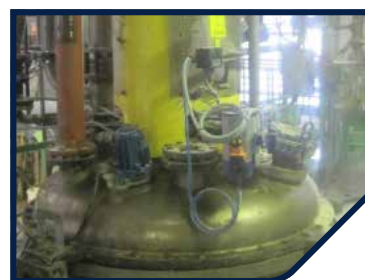
| Product: | CDMSC with SP2 Seal Support System |

After initially seeking assistance from the original seal provider, the manufacturer turned to AESSEAL® for help. AESSEAL® recommended a CDMSC™ dual mechanical seal along with a SP2 seal support system. The CDMSC™ seal is ideally suited to this application with its ability to accept up to 6mm of radial movement (the original seals installed on the mixer were designed to accept just 0.1mm of radial movement). The CDMSC™ seal has now been installed for over 6.5 years and continues to operate without issue, already saving over €3.5 million (\$3.8 million) and repaying the upfront investment within 2 weeks.
