ENVIRONMENTAL TECHNOLOGY

Seal upgrade improves mixer reliability 5200%

A corn milling facility in the UK had lip seals fitted to the shaft of a dough mixer.

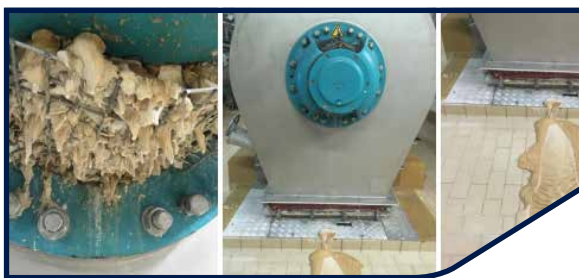
Before

The dough mixer is a critical piece of equipment on site and runs continuously. Maintenance of the dough mixer is carried out during planned shutdown periods. The lip seals were fitted to both the drive end (DE) where the product is powder, and the non drive end (NDE) where the product is wet. Both the DE and NDE lip seals started leaking 1 to 2 weeks after installation. The loss of product containment was both unhygienic and hazardous to personnel, and a solution needed to be found.

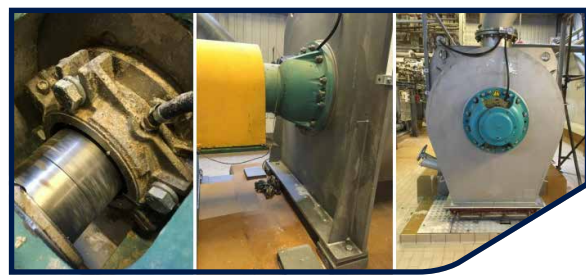
After

The company approached AESSEAL® for a solution. AESSEAL® recommended fitting RDSX™ split single seals. Adapter plates were made to allow the seals to be fitted to the dough mixer. The seals were fitted with Flowtrues in order to control the seal environment and keep the product away from the seal faces. The NDE seal was installed in March 2019 and the DE seal in November 2019, and have run without issue since that time. The new seals have proved to be highly effective in sealing both the dry (DE) and wet (NDE) ends of the dough mixer, eliminating clean-up costs by preventing product loss and consequently removing the environmental issues. The split seal design means that if required, the seals can be replaced without the need to remove the bearing housings and the gearbox on the drive end of the machine.
