ENVIRONMENTAL TECHNOLOGY

Improved Safety and Reliability

Industry:	Metal Processing
Product:	CDSA™ and Water Management System
Application:	Caustic Chemical Pump
MTBF Increase:	666% (and counting)
Reference N.O:	CS0031

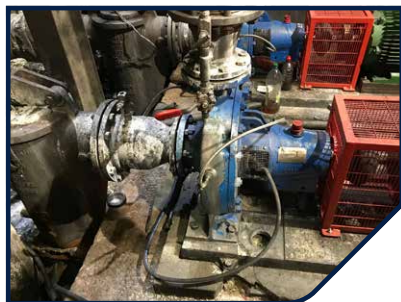
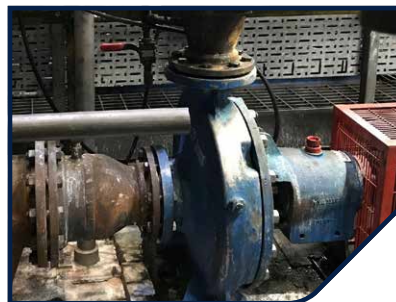
The pump was fitted with a single mechanical seal connected to a quench to drain system to ensure the caustic product did not crystallise inside the seal causing it to fail. The mean time between failure (MTBF) was just 6 months and the company were looking to improve reliability and prevent the escape of hazardous product to the environment.

AESSEAL® recommended replacing the single seal with a CDSA™ dual mechanical seal along with a Water Management System. The dual seal and water management system prevents escape of hazardous product in the event of inner seal failure. The water management system provides a closed loop for the seal barrier fluid and helps improve seal reliability as the seal faces are lubricated by a clean and cool barrier fluid. The water management system utilised the EasyClean™ vessel which is designed so that it can be easily cleaned.

The new solution was installed in March 2020 and has been running trouble free to date (almost 4 years later at time of writing). The use of a closed loop water management system has significantly reduced water usage by the application and the customer intends to upgrade the standby pump in the same manner in the coming year.
