MagTecta improves gearbox reliability

A gas processing facility in the US was experiencing water ingress and oil leakage into one of its gearboxes.

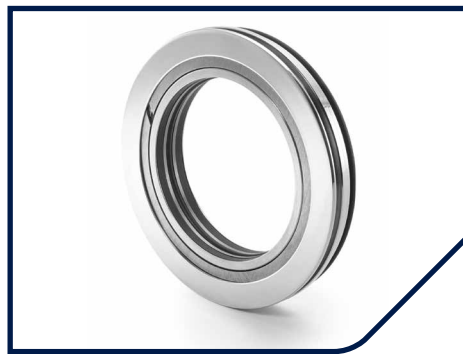
The mean time between failure (MTBF) was approximately two years but varied. The gearbox was sealed with a lip seal which caused fretting of the shaft. This would require replacing when the gearbox failed at a cost of approximately US\$9,000. Leaking oil was also resulting in general housekeeping issues, as well as being a slip hazard.

‘Shaft fretting issues eradicated’

AESSEAL® recommended replacing the lip seal with a MagTecta™ bearing isolator. The MagTecta™ was installed in November 2018 and is running leak-free to date. The MTBF has already improved to over 3.5 years and the customer is saving approximately US\$2,000 for every year that the seal runs leak free.
