AESSEAL® solves leakage problem at US

The installation of double cartridge mechanical seals and a water management system has solved a persistent leakage problem at a US paper mill.

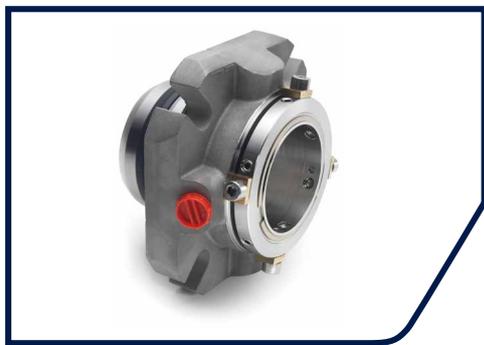
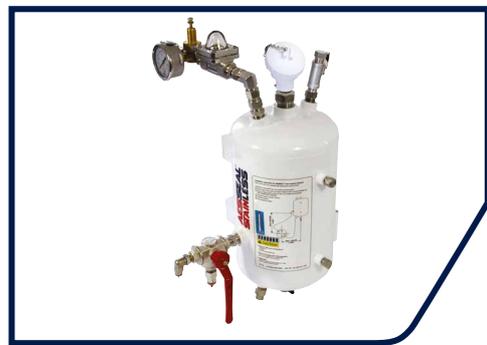
A condensate separator pump was running dry and failing at least once a year. In addition to the cost of repairs, the single seal was leaking hot condensate to the floor. The company's seal supplier had failed to offer any suggestions as to how the problem might be corrected, so the company consulted AESSEAL® to find a possible remedy.

The solution was found with the installation in March 2022 of 1.750" DMSF™ double cartridge mechanical seals and a 25 litre SWC™ water management system, along with a heat guard to eliminate the possibility of injuries from contact with the hot surface of the tank.

There have been no seal failures since installation. The separator runs dry from time to time but the SWC™ condensate system ensures that the seal is constantly lubricated. As a result, the company has saved around \$3,500 a year in repairs, and more than \$500 in the cost of condensate. The AESSEAL® equipment has meant improved reliability, and no leakage of condensate to the floor of the plant.
