## Upgrade solves contamination problem

Industry:	Pulp & Paper
Product:	LabTecta®
Application:	Oscillator Unit Gearbox
MTBF Increase:	500% (and counting)
Reference N.O:	TD3093619

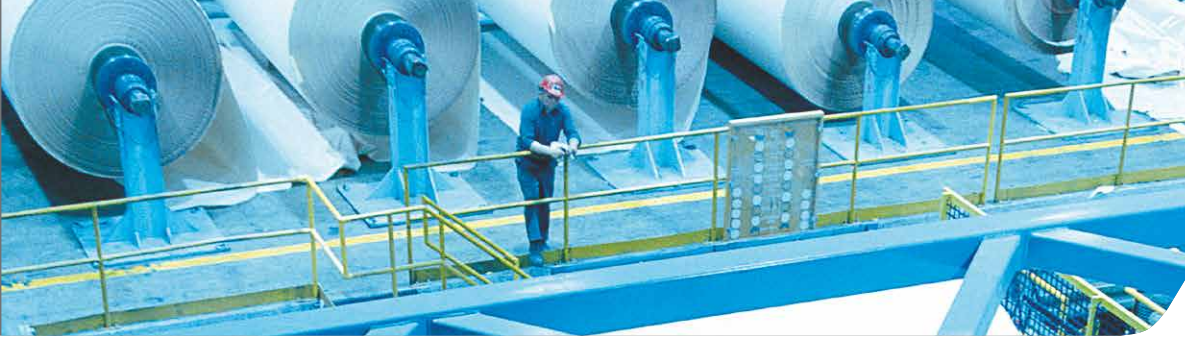
A pulp and paper mill in south Wales was having problems with contamination in its oscillator unit gearbox.

The unit's close proximity to the paper machine meant that it was vulnerable to the ingress of water and stock, contaminating not only the gearbox, but also the split roller unit and eccentric bearing. This led to the premature failure of the bearings, which in turn resulted in recovery costs and in unplanned downtime while the necessary repairs were carried out.

The solution put forward by AESSEAL® was the installation of the company's range of LabTecta® bearing protectors. These incorporate recognised lip seal technology into AESSEAL's advanced labyrinth design, preventing both solids and moisture from entering the bearing chamber or damaging the integrated lip seal.

AESSEAL® engineers designed eight individual solutions for the eight off-sealing locations on the oscillator assembly. Working with a mechanical machinist company, they succeeded in modifying the design of the eccentric bearing unit to enable it to accept the bearing protectors.

Since the installation in May 2022, the new system has significantly limited the ingress of water and contaminants, improving the MTBF from three to more than eighteen months, cutting down on maintenance while at the same time reducing the cost of lubrication. The company is now in the process of ordering a second set of LabTecta® bearing protectors for a standby unit.
