AESSEAL® mixer seal solves reliability problem

A locally-made double mixer seal being used by the Ela Kimya chemical company in Istanbul was failing every few months because its elastomers and inner seal design were not suitable for the application.

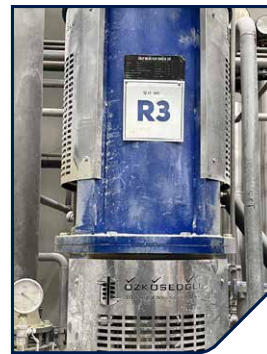
‘Reliability increased from <3 months to >18 months’

Industry: Chemical
Product: SCMS-DWB™
Application: Mixer
MTBF Increase: 500% (and counting)
Reference N.O: TD3104245

This unreliability was causing the company significant losses both financially and in lost production, since the equipment was a critical part of their production process. AESSEAL® recommended its 100mm SCMS-DWB™ mixer seal with Kalrez O-rings. This was installed in December 2022, and 18 months later is still working without a problem. The correct elastomer and seal face selection along with professional seal design have resolved the problems arising from seal failures, reducing downtime and increasing production efficiency.
