CFFC™ dual seal solves reliability issues

Industry:	Power
Product:	CFFC™
Application:	Hot Oil Main Pump
MTBF Increase:	60% (and counting)
Savings:	€16,000 (and counting)
Reference N.O:	TD3111622

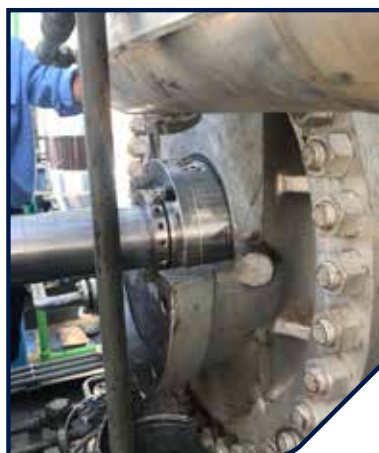
When AESSEAL® was consulted about a possible alternative, it recommended the installation of its CFFC™ dual seal. These robust seals are designed for use on difficult applications, with monolithic seal faces which maintain their flatness under temperature fluctuations, and which minimize the effects of pressure distortion.

'Robust seal for use on difficult applications'

The CFFC™ was installed in December 2020 and has been working without a problem for almost four years, saving the company an estimated €16,000 in repair costs, and leading to further orders at this plant and at others belonging to the company in the same area.
