## LabTecta® ends contamination problem at Australian mining company

Industry:	Mining
Product:	LabTecta®66PB-HD
Application:	Conveyor Pulleys
MTBF Increase:	100% (and counting)
Savings:	Maintenance & production savings
Reference N.O:	TD3126271

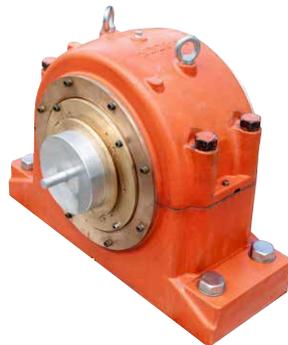
To remedy the problem, AESSEAL® recommended the installation of its LabTecta®66PB-HD bearing protection system. Contact sealing solutions have very short lives because the misalignment overloads the sealing surfaces. The AESSEAL® LabTecta®66PB-HD eliminates the cause of more than 50% of bearing failures by absorbing the misalignment and maximizing the performance of the seal.

The LabTecta®66PB-HD has now been operating effectively for more than two years since it was installed in January 2024, resulting in major savings for the company by eliminating the need for costly maintenance and the consequent halts in production.
